# **Upper San Fernando Dam**

## Introduction

In light of the importance of the San Fernando Dam case histories and their prominence in the literature, it is important to show how GeoStudio, and in particular QUAKE/W, can be used to analyze cases like this. This example concentrates on the Upper Dam.

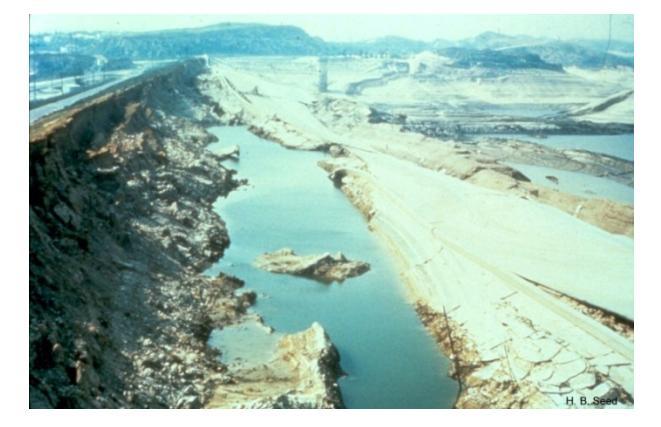
The earthquake shaking initiated a major failure on the upstream side of the dam. The photos in Figure 2, Figure 3 and Figure 4 show some of the conditions after the earthquake. Of significance is the very steep slide head scarp (Figure 2) and very marginal freeboard that remained after the failure.

Figure 2. Upstream face of the dam after the drawing down the reservoir.

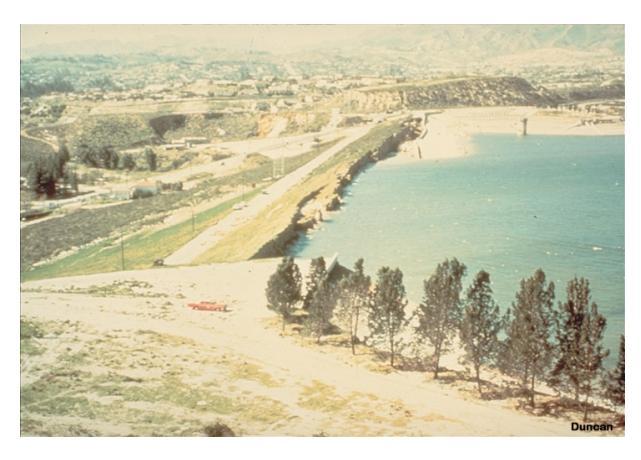
Figure 3. General view of the slide head scarp.

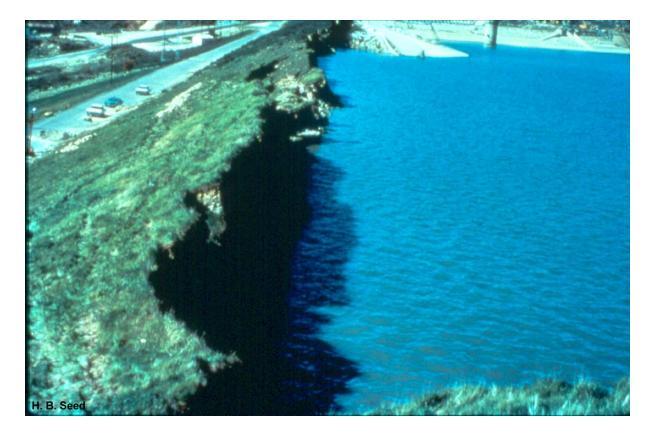
Figure 4. A close-up view of the slide head scarp.

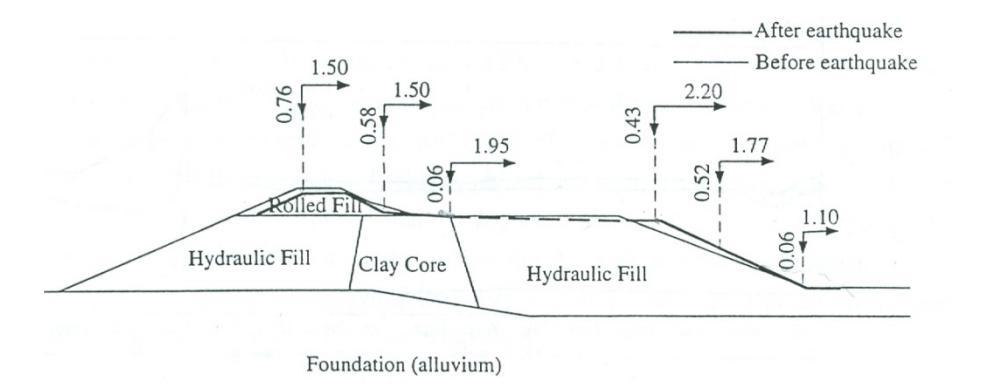
Surveys taken after the earthquake revealed that the entire upper portion of the dam had moved downstream around 2 m and the crest had moved downward around 0.75 m. Based on the sketch in Figure 5, only the upper rolled-fill portion moved on the upstream side. Of significance is the movement along the surface of the berm. Here, the movements were predominantly in the lateral direction with hardly any settlement (Figure 6).

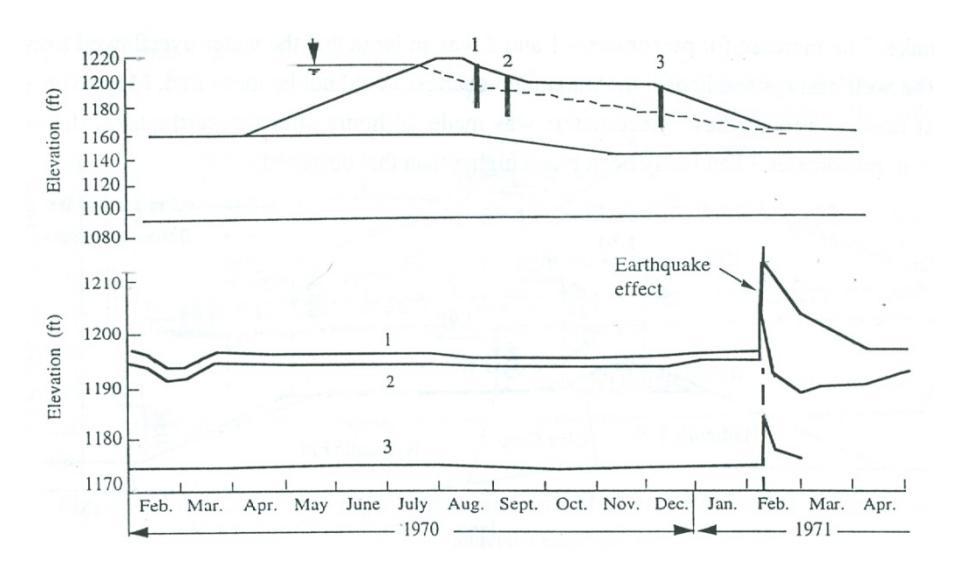
There were three piezometers in the dam (Figure 7). As indicated by the piezometric records, there was a sudden and dramatic increase in pore-water pressures. Even 24 hours after the earthquake, water was still running out of the top of Piezometers 1 and 2. This is of significance, since these piezometers are in the core area of the dam, especially Piezometer 2. The peak in Piezometer 3 was likely higher than what was measured, due to some dissipation within the 24 hours between the event and the readings. These piezometers provide definitive evidence that substantial excess porewater pressures resulted from the shaking.

Figure 7. Piezometers and pore-water pressure responses due to the shaking.

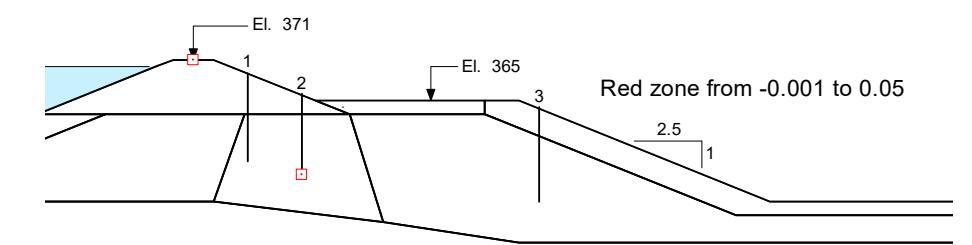
Figure 23 shows contours of q/p' stress ratios under the initial static stresses. A point of significance is the high q/p' ratios in the hydraulic fill underneath the dam crest. This means that there is a zone where the initial q/p' points are near the collapse surface, as discussed previously. The soil strength in this zone could easily fall down to the steady-state strength with a small amount of shaking. There is no yellow shaded area in Figure 24, which indicates that there is zone of initial stress states that are near but still below the collapse surface.

Figure 24. Zone of liquefaction based on initial q/p' stress ratios relative to collapse surface.

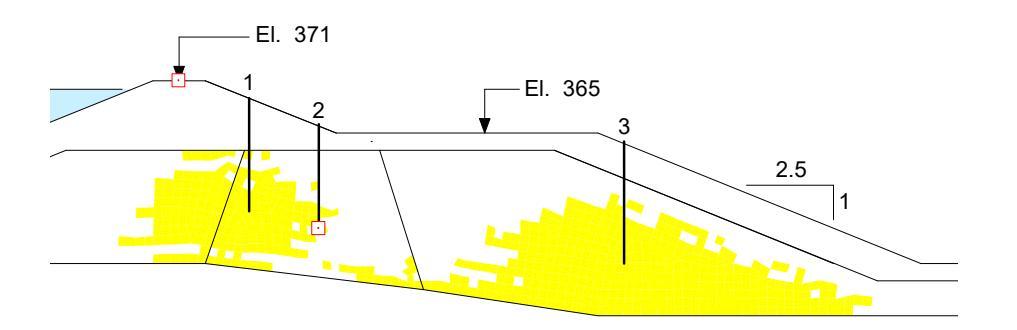
During the shaking, excess pore-water pressures will develop, causing other elements to reach the collapse surface as discussed earlier; in other words, to liquefy. Figure 25 shows the liquefied zone at the end of the shaking.

#### Figure 25. Liquefied zone at the end of shaking.

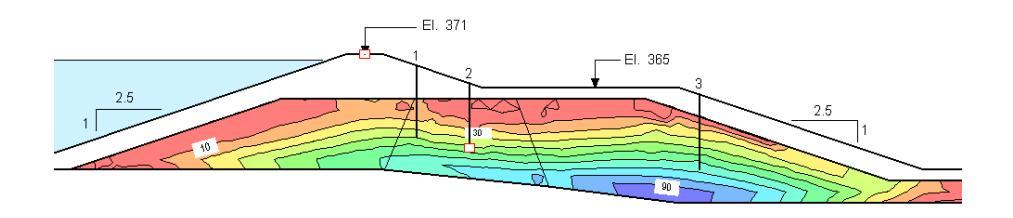
Figure 26 shows contours of the excess pore-water pressure at the end of the shaking. The highest excess pore-water pressures (90 kPa) are at the bottom of the hydraulic fill below the downstream berm crest.

Figure 26. Contours of excess pore-water pressure at the end of shaking.

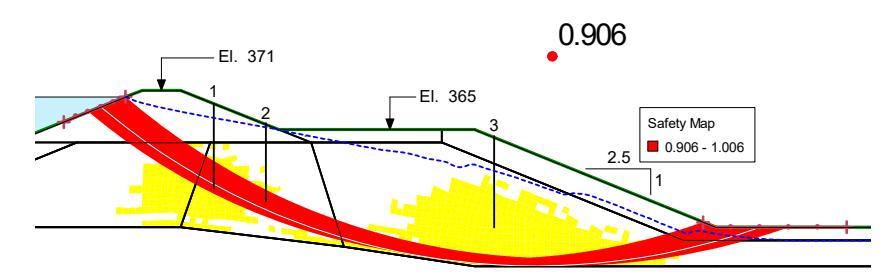
Repeating the pre-earthquake stability analysis, but with post-earthquake pore-water pressures and with  $C_{ss}$  strengths in the liquefied zones, results in factors of safety of close to unity (1.0). Figure 28 shows the situation for the overall stability, and Figure 29, the stability of the downstream slope at the end of the earthquake. In both cases, the low safety factors suggest that the structure was marginally stable at the end of the earthquake, which it intuitively likely was.

Figure 28. Post-earthquake overall stability.

It is of significant interest that the overall critical slip surface in Figure 28 on the upstream face is exactly in the area where large longitudinal cracks had formed under the reservoir water surface. These cracks only became visible after the reservoir was drawn down, some 12 days after the earthquake.

The safety factor for the overall stability case is 0.923 if the steady-state strength is used in the liquefied zones of the dam (Figure 28) as compared to 1.11 using the collapse surface properties ( $\phi'$  = 20; C<sub>ss</sub> = 35 kPa) and 1.28 using effective stress strength properties ( $\phi'$  = 34). In the downstream local case, the safety factor is 0.885 if the steady-state strength is used in the liquefied zones of the dam (Figure 29) as compared to 0.978 using the collapse surface properties ( $\phi'$  = 20; C<sub>ss</sub> = 35 kPa) and 1.054 using effective stress strength properties ( $\phi'$  = 34). Consequently, it could be argued that, in the local downstream case, the C<sub>ss</sub> strength is not required to explain the observed behavior, but it is certainly required to explain the overall behavior.

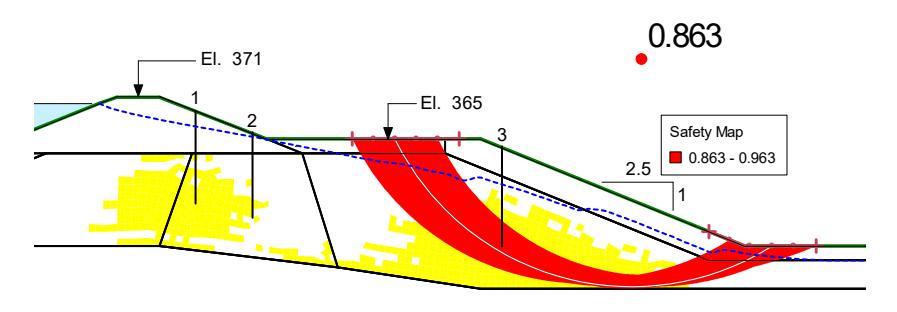
Figure 29. Post-earthquake stability of the downstream slope at the end of the earthquake.

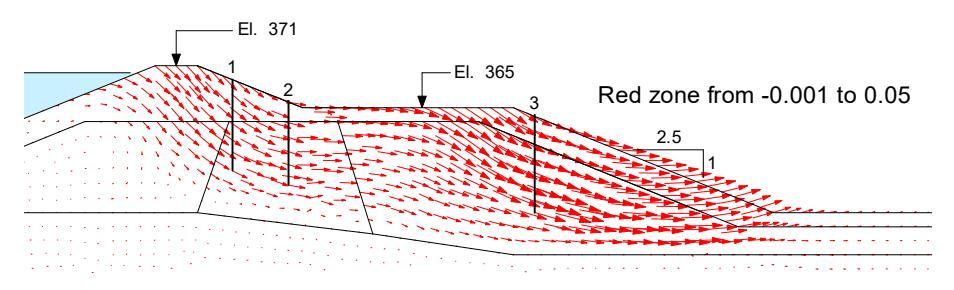
Figure 31 shows the displacement vectors from the post-earthquake SIGMA/W stress re-distribution. The movement patterns seem to be a reasonable approximation of what actually happened. The vectors in the upper rolled fill section are down and to the right, and the movement vectors start on the upstream face in the area where the longitudinal cracks developed. To the right of the upper rolled-fill section, the movement is predominately horizontal, which is also consistent with the observations discussed earlier.

Figure 31. Post-earthquake movement directions.

There seems to be, in part, a localized failure on the downstream side. The movements are greater in this area than further upstream. They are distinctly downward at the crest, and lateral and upward at the toe. The strong lateral movements in the toe area are consistent with the pressure ridge that had formed here, the compression failures observed in the outlet conduit and the down slope tipping of the concrete manhole. The movement vectors, in general, are somewhat characteristic of a localized near circular slip failure.

Generally, the computed movement patterns are entirely consistent with the field observations, and the conclusions arrived at by Seed et al. They concluded that, the zone of movements within the dam extended vertically over a large portion of the embankment and was not limited to well-defined slip surface at depth. The computed movement patterns in Figure 31 certainly confirm this.

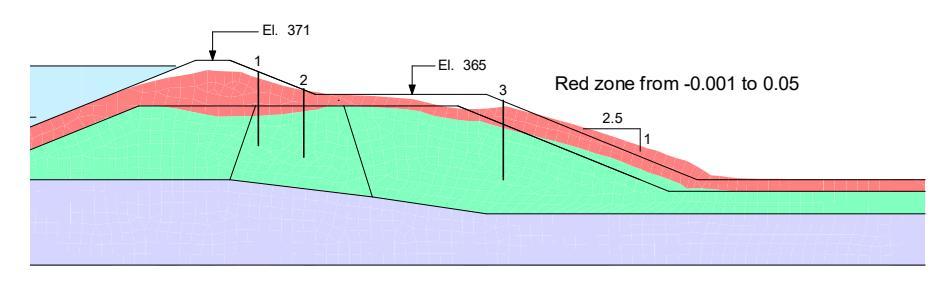
Another way to view the movements is as a deformed section (Figure 32). The view gives an appreciation of the down and right movement of the upper rolled fill section and compression bulging in the downstream toe area.
