# **Upper San Fernando Dam**

## Introduction

In light of the importance of the San Fernando Dam case histories and their prominence in the literature, it is important to show how GeoStudio, and in particular QUAKE/W, can be used to analyze cases like this. This example concentrates on the Upper Dam.

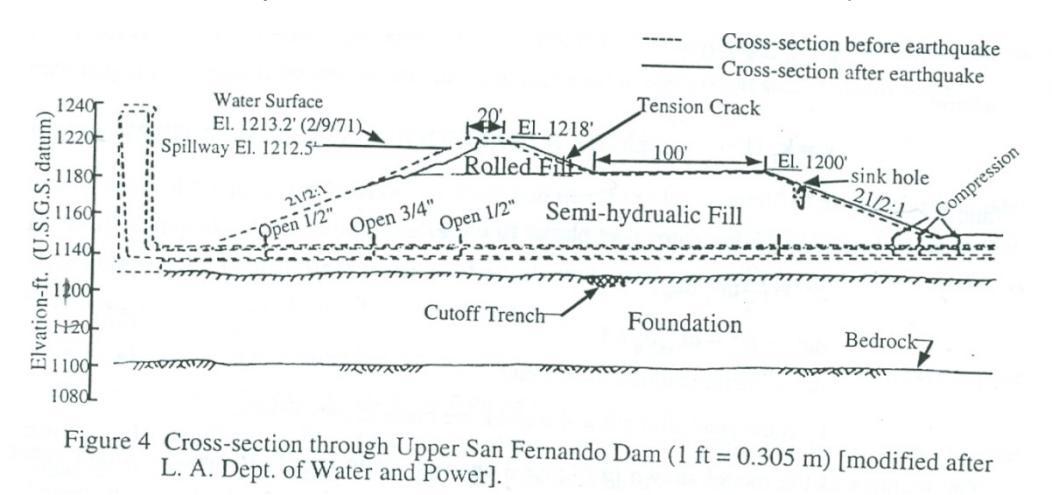
#### Figure 5. Sketch of the Upper San Fernando Dam.

The Upper San Fernando Dam was constructed directly on the native streambed alluvium (Figure 5). The main body of the dam was constructed by what is known as a semi-hydraulic fill method. The material was hauled to the site by wagons and dumped into a pond where it was dispersed by water jets operating from barges. Although there is no mention of it in the publications, this technique must have created an outer shell of material compacted to some degree by the construction traffic. The material for this portion of the dam was obtained from the valley floor.

The hydraulic fill method was used up to El. 1200 feet (365 m) and then was topped-off with compacted fill to El. 1218 (371 m). This resulted in a 100-foot berm on the downstream side.

Surveys taken after the earthquake revealed that the entire upper portion of the dam had moved downstream around 2 m and the crest had moved downward around 0.75 m. Based on the sketch in Figure 5, only the upper rolled-fill portion moved on the upstream side. Of significance is the movement along the surface of the berm. Here, the movements were predominantly in the lateral direction with hardly any settlement (Figure 6).

The low level outlet conduit was inspected after the earthquake, and the condition of the conduit provided some interesting clues about the movement that occurred. On the upstream side, the conduit was extended as indicated by the openings noted in Figure 5. Toward the downstream toe, however, the conduit was forced into compression, as indicated by compression failures.

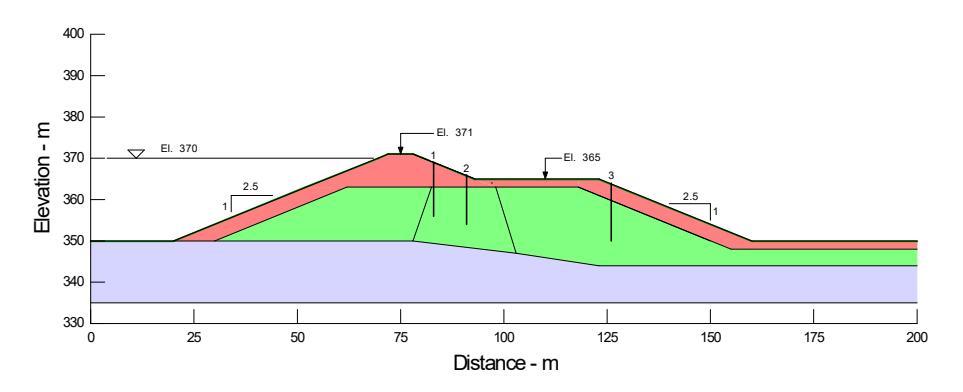
Figure 8. Numerical analysis model of the Upper San Fernando Dam.

For the analysis here, the Upper Dam cross-section was idealized, as shown in Figure 8.

Seed et al. present the cross-section as having a clay core. For the analysis here, the entire hydraulic fill is treated as one material. The reasons for this, as will be discussed below, is that the results this way give a picture closer to what actually happened. Furthermore, Peter Byrne in his R.M. Hardy Keynote address at the 2006 Canadian Geotechnical Conference in Vancouver suggested that stratification may have a significant impact on the potential for liquefaction. He looked at the impact of thin layers of clay amongst layers of loose sand and found that the impeded drainage resulting from the clay layers had a significant impact on the liquefaction response of the material in general. It is not difficult to imagine that there was some stratification at the Upper San Fernando Dam in the core area, especially considering the semi-hydraulic fill placement procedure used. Based on these more recent concepts, it is possible that there was some generation of excess pore-water pressures and associated strength loss in the core area, just like in the remainder of the hydraulic fill. The piezometer records noted earlier strongly suggest this was indeed the case.

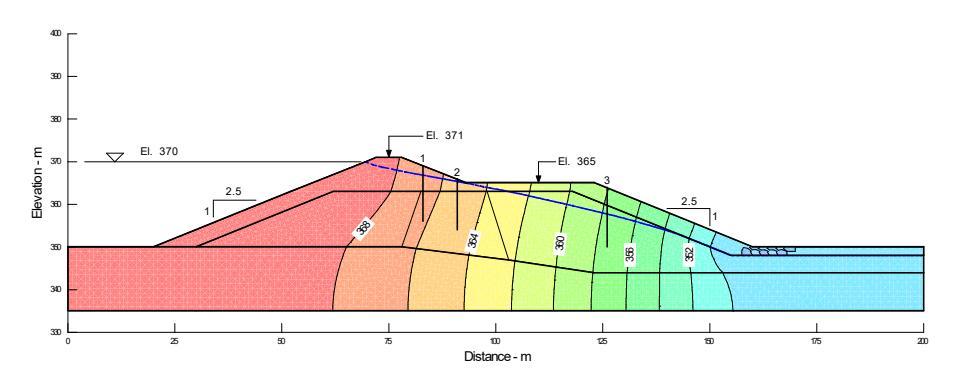
Figure 17. Long term steady-state seepage and pore-water pressure conditions.

Figure 17 shows the resulting piezometric line (water table) and total head contours (equipotential lines) for the initial SEEP/W analysis. Note that the piezometric line comes very close to the ground surface at the toe of the upper rolled section.

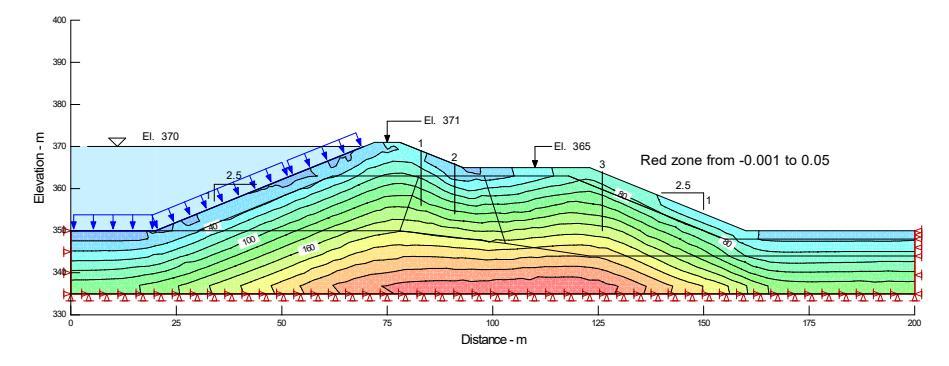
Figure 18. Initial static vertical effective stresses.

The resulting vertical effective stresses for the Initial static analysis are as shown in Figure 18.

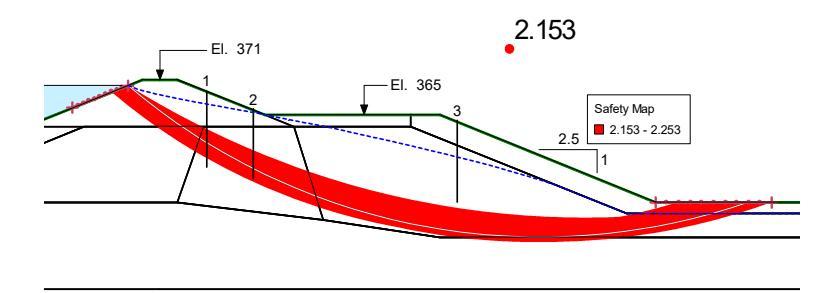
Figure 19. Overall margin of safety before the earthquake.

Based on the SEEP/W pore-water pressures and QUAKE/W static stresses, the factor of safety of the overall slope is well above 2.0 (Figure 19). This is consistent with the findings by Seed et al., who concluded that the margin of safety against instability under the static conditions was fairly high.

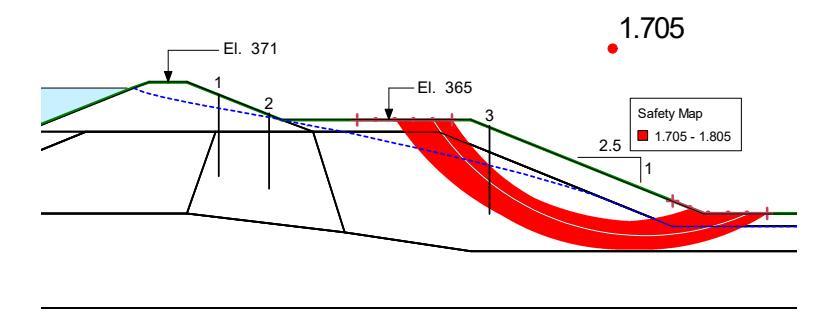
Figure 20. Downstream slope margin of safety before the earthquake.

The safety factor of the downstream slope of the hydraulic fill section is shown in Figure 20. As with the overall factor of safety, the factor of safety for this potential mode of failure is also fairly high. The factor of safety in the red band is between 1.70 and 1.80.

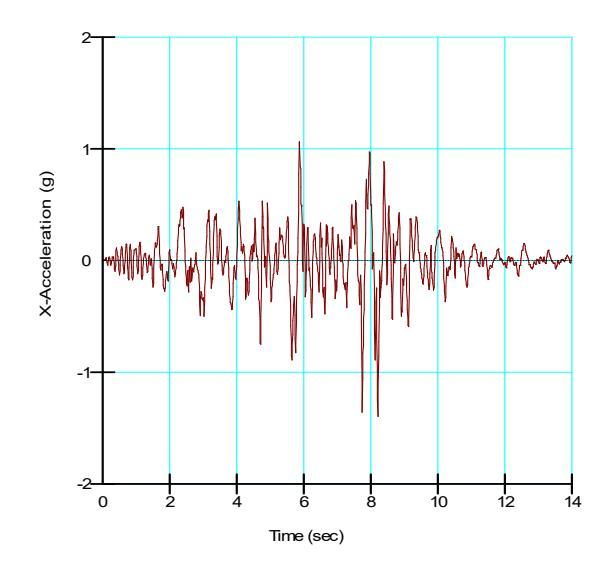
Figure 21. Acceleration versus time at the Dam crest.

Figure 21 shows the response at the History Point located at the crest of the Dam. There is not much difference between this record and the input record in Figure 13. There are a couple of spikes greater than 1g, but outside these spikes the response is more or less a reflection of the earthquake record. In other words, there is no significant amplification or unrealistic damping. This is consistent with the conclusions reached by Seed et al.

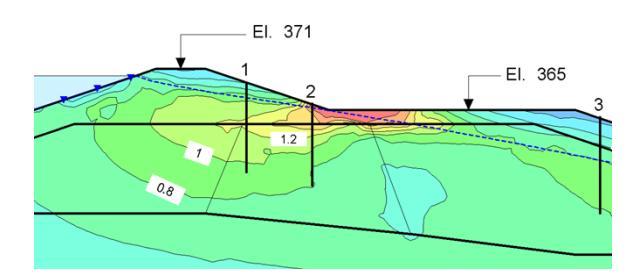
Figure 23. q/p' stress ratios under initial static stresses.

Figure 23 shows contours of q/p' stress ratios under the initial static stresses. A point of significance is the high q/p' ratios in the hydraulic fill underneath the dam crest. This means that there is a zone where the initial q/p' points are near the collapse surface, as discussed previously. The soil strength in this zone could easily fall down to the steady-state strength with a small amount of shaking. There is no yellow shaded area in Figure 24, which indicates that there is zone of initial stress states that are near but still below the collapse surface.

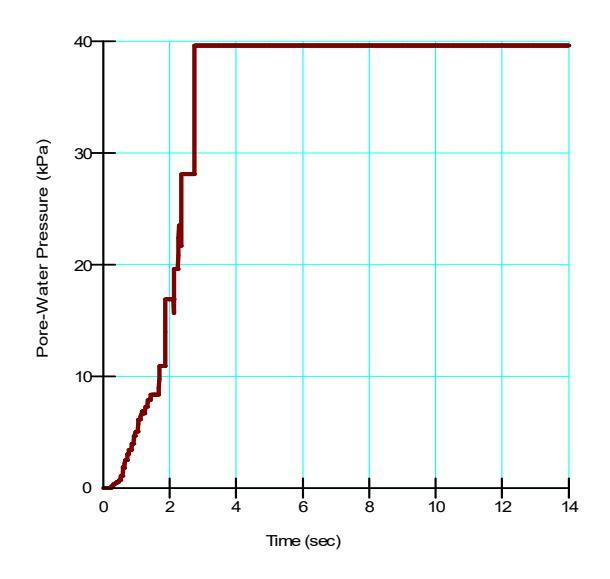
Figure 27. Excess pore-water pressure at Piezometer 2.

Figure 27 shows the build-up of excess pore-water pressures at the bottom tip of Piezometer 2. The maximum excess pore-water pressure is 43.5 kPa. This is a pressure head of 4.4 m (about 14.5 feet).

The View Results Information command can be used to get the final total *H* at the base tip of Piezometer 2. The computed *H* is 369 m. The ground surface at Piezometer 2 is 366 m. The total head H, being greater than the ground surface elevation, means water would be flowing from the piezometer casing, which is in keeping with observations.

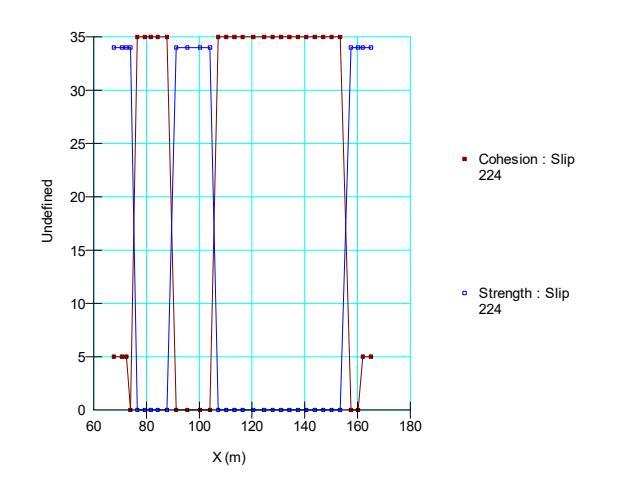
Figure 30. Strength along the overall critical slip surface.

Figure 30 shows the cohesive strength along the overall critical slip surface. Note how along much of the slip surface, the cohesion is at 35 kPa, which is the specified  $C_{ss}$ . Where  $C_{ss}$  is 35,  $\phi'$  is zero and, therefore, the frictional component of the strength is zero.
