The Upper San Fernando Dam

1 Background

3 Purpose

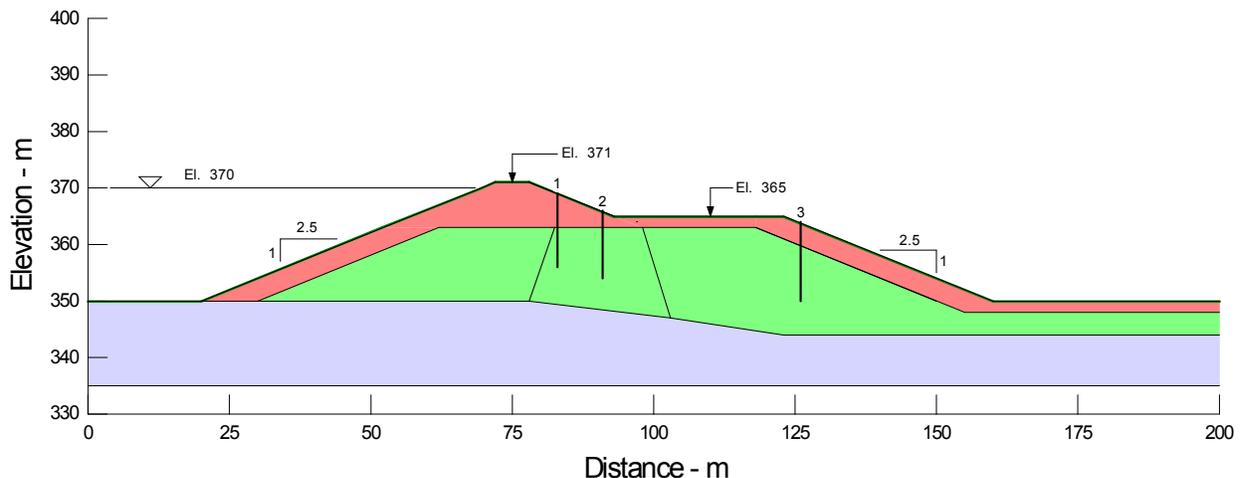
For the analysis here, the Upper Dam cross-section was idealized, as shown in Figure 8.

Figure 8 Numerical analysis model of the Upper San Fernando Dam

Seed et al. present the cross-section as having a clay core. For the analysis here, the entire hydraulic fill is treated as one material. The reasons for this, as will be discussed below, is that the results this way give a picture closer to what actually happened. Furthermore, Peter Byrne in his R.M. Hardy Keynote address at the 2006 Canadian Geotechnical Conference in Vancouver suggested that stratification may have a significant impact on the potential for liquefaction. He looked at the impact of thin layers of clay amongst layers of loose sand and found that the impeded drainage resulting from the clay layers had a significant impact on the liquefaction response of the material in general. It is not difficult to imagine that there was some stratification at the Upper San Fernando Dam in the core area, especially considering the semi-hydraulic fill placement procedure used. Based on these more recent concepts, it is possible that there was some generation of excess pore-pressures and associated strength loss in the core area, just like in the remainder of the hydraulic fill. The piezometer records noted earlier strongly suggest this was indeed the case.

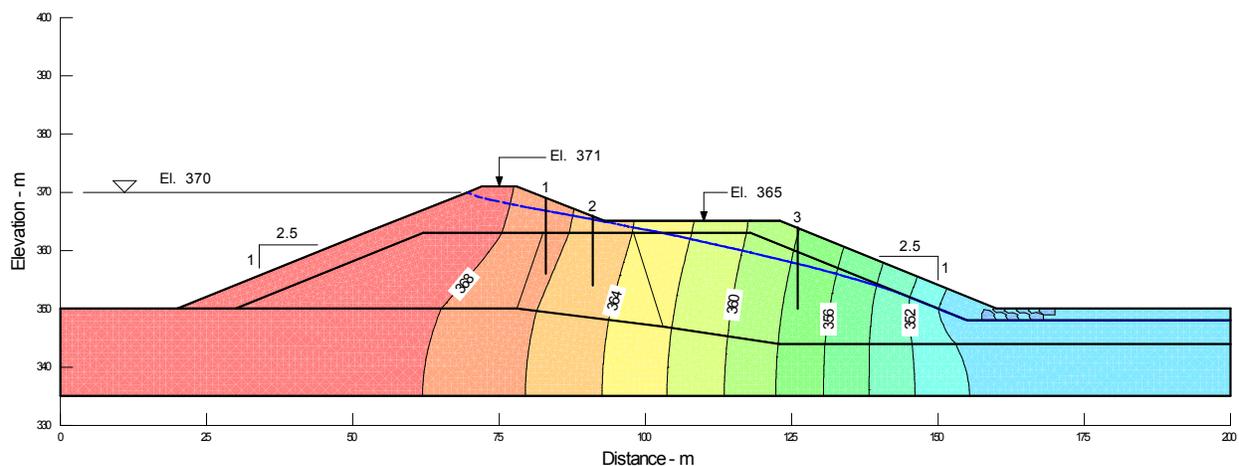
Figure 11 shows the resulting piezometric line (watertable) and total head contours (equipotential lines). Note that the piezometric line comes very close to the ground surface at the toe of the upper rolled section.

Figure 11 Long term steady-state seepage and pore-pressure conditions

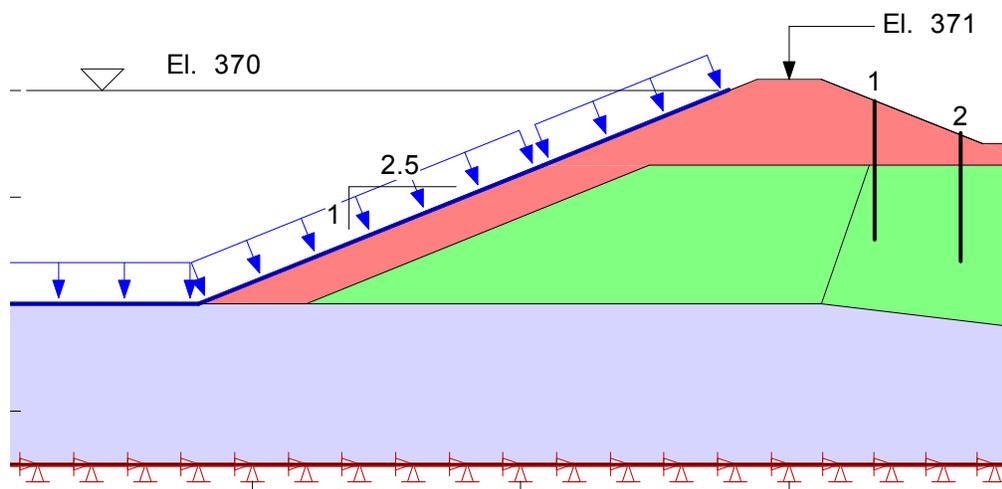
It is important to include the weight of the reservoir water in the static stress analysis. This is done by applying a fluid pressure boundary on the region edges in contact with the reservoir. This is illustrated in Figure 12. The resulting vertical effective stresses, for example, are as shown in Figure 13.

Figure 12 The reservoir water weight boundary condition

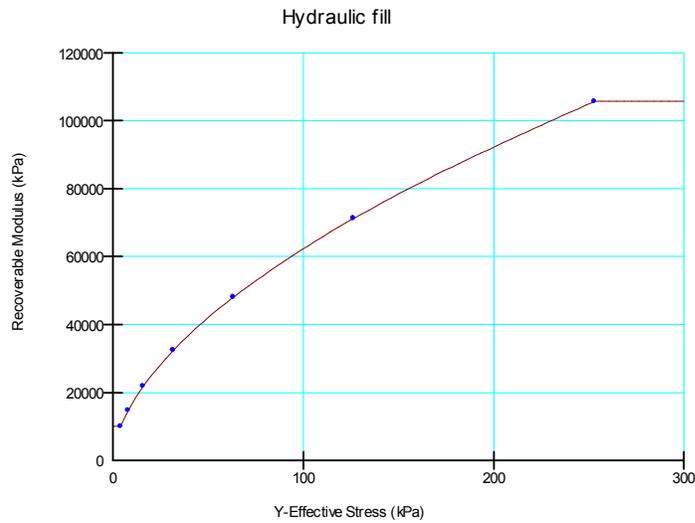
The second piece of data required for the MFS pore-pressure model is the Recoverable Modulus function. This is basically the slope of an unloading curve from a one-dimensional odometer test. The curve used in the analysis here is shown in Figure 19.

Figure 19 Recoverable modulus function

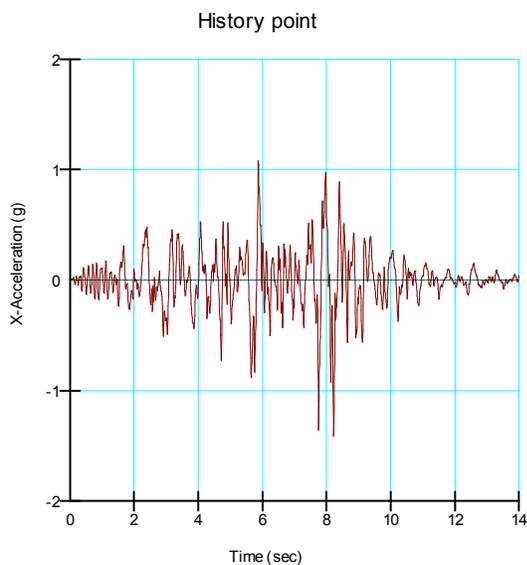
Figure 20 shows the response at the crest of the Dam. There is not much difference between this record and the input record in Figure 16. There are a couple of spikes greater than 1g, but outside these spikes the response is more or less a reflection of the earthquake record. In other words, there is no significant amplification or unrealistic damping. This is consistent with the conclusions reached by Seed et al.

Figure 20 Acceleration versus time at the Dam crest

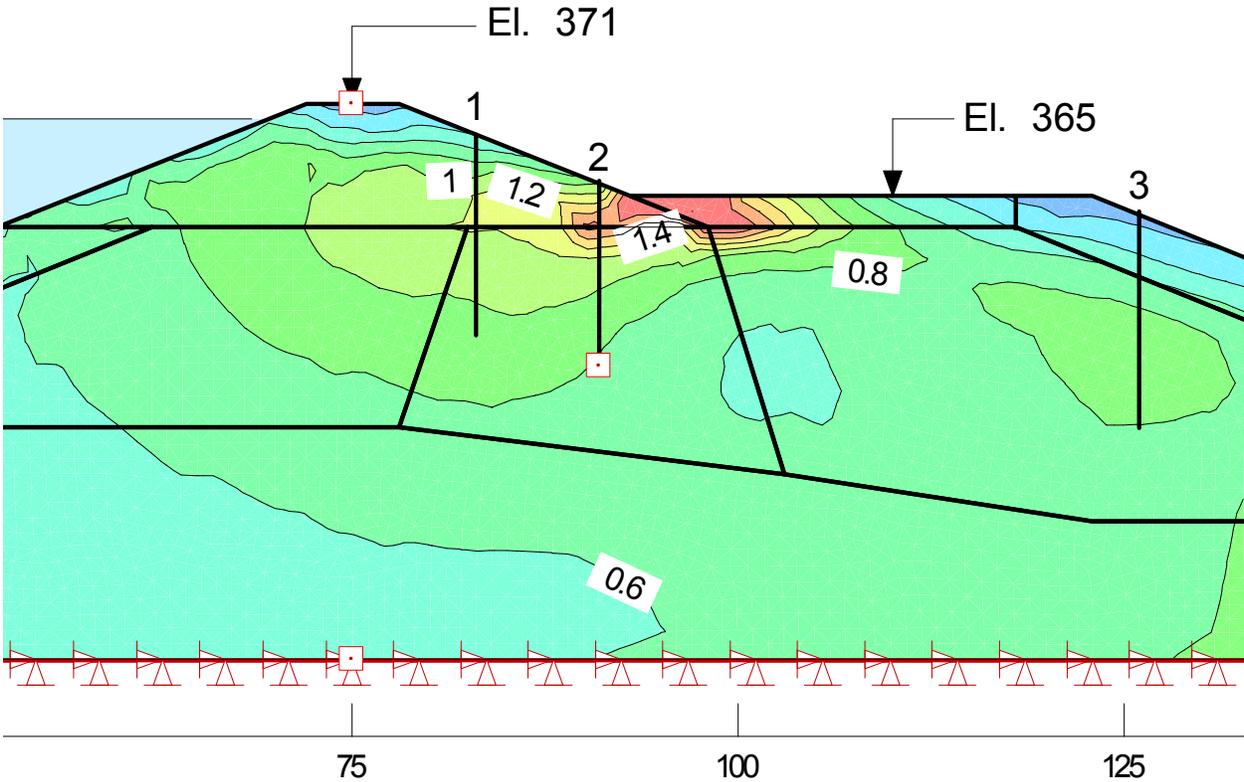
Figure 22 shows contours of q/p' stress ratios under the initial static stresses. A point of significance is the high q/p' ratios in the hydraulic fill underneath the dam crest. This means that there is a zone where the initial q/p' points are near the collapse surface, as discussed earlier in Section 7. The soil strength in this zone could easily fall down to the steady-state strength with a small amount of shaking. There is no yellow shaded area in Figure 23, which indicates that there is zone of initial stress states that are near but still below the collapse surface.

Figure 22 q/p' stress ratios under initial static stresses

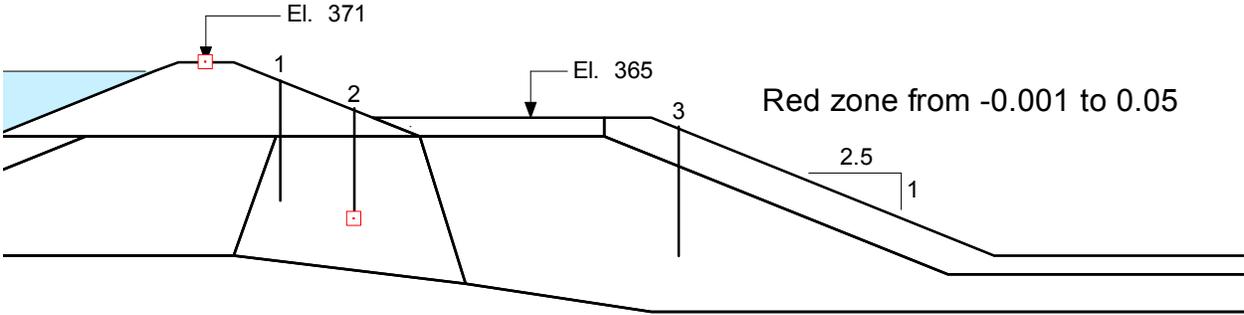
Figure 23 Zone of liquefaction based on initial q/p' stress ratios relative to collapse surface
