The Upper San Fernando Dam

1 Background

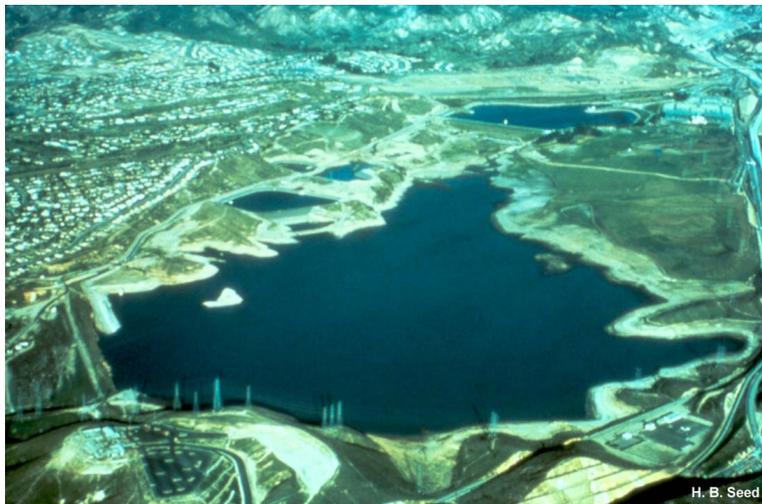
Figure 1 shows an aerial view of the area. The Lower Dam is on the left side of the picture and the Upper Dam is towards the upper right of the picture. US Interstate Freeway 5 is on the right of the picture.

Figure 1 The San Fernando dams and reservoirs

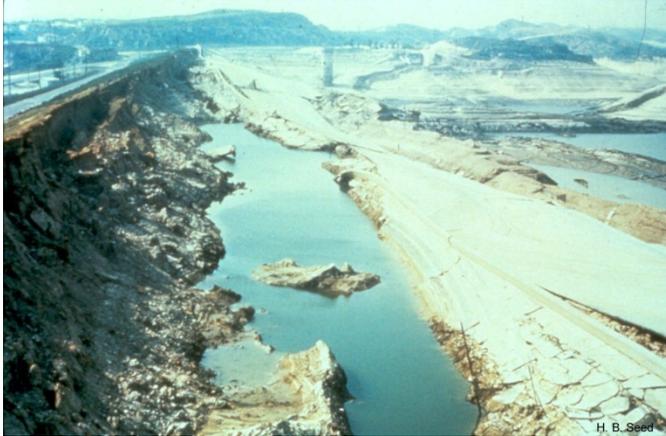
Figure 2 Upstream face of the dam after the drawing down the reservoir

The earthquake shaking initiated a major failure on the upstream side of the dam. The photos in Figure 2, Figure 3 and Figure 4 show some of the conditions after the earthquake. Of significance is the very steep slide head scarp (Figure 2) and very marginal freeboard that remained after the failure.

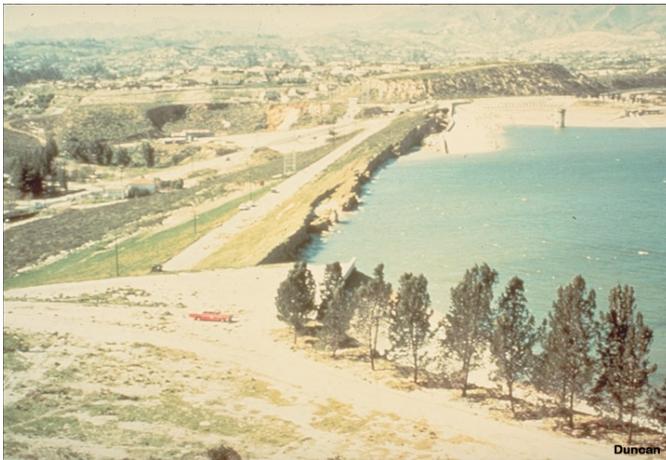
Figure 3 General view of the slide head scarp

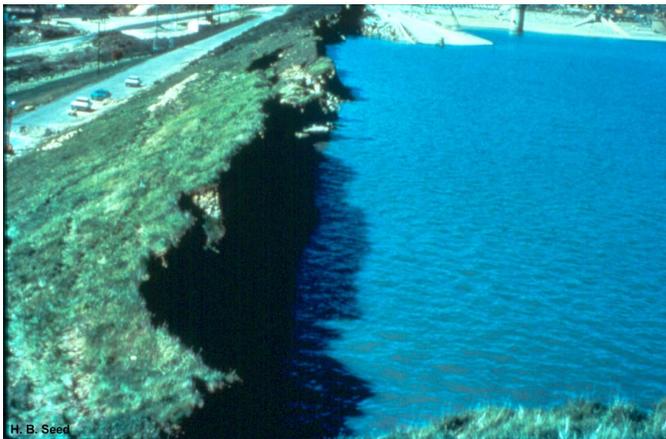
Figure 4 A close-up view of the slide head scarp

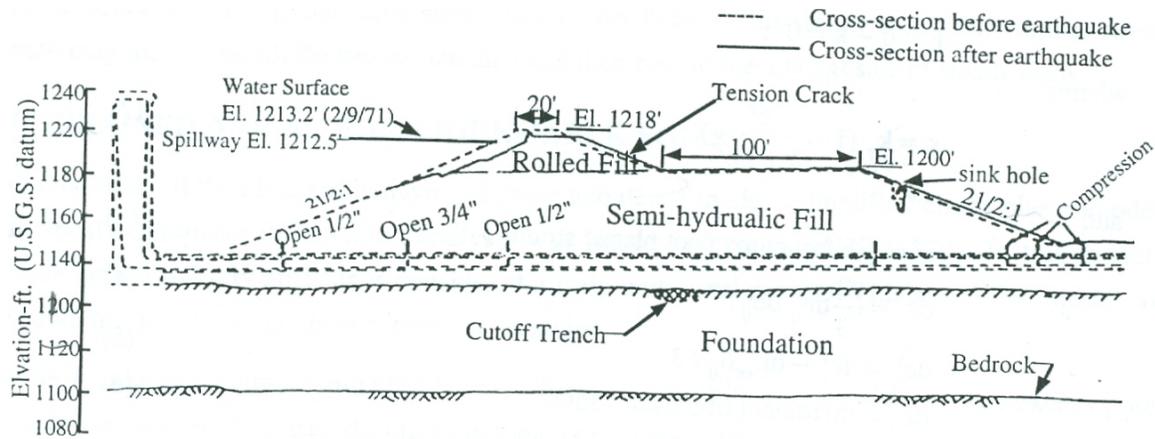
The following diagram shows a sketch of the Upper San Fernando Dam. The dam was constructed directly on the native streambed alluvium. The main body of the dam was constructed by what is known as a semi-hydraulic fill method. The material was hauled to the site by wagons and dumped into a pond where it was dispersed by water jets operating from barges. Although there is no mention of it in the publications, this technique must have created an outer shell of material compacted to some degree by the construction traffic. The material for this portion of the dam was obtained from the valley floor.

The hydraulic fill method was used up to El. 1200 feet (365 m) and then was topped-off with compacted fill to El. 1218 (371 m). This resulted in a 100-foot berm on the downstream side.

Figure 4 Cross-section through Upper San Fernando Dam (1 ft = 0.305 m) [modified after L. A. Dept. of Water and Power].

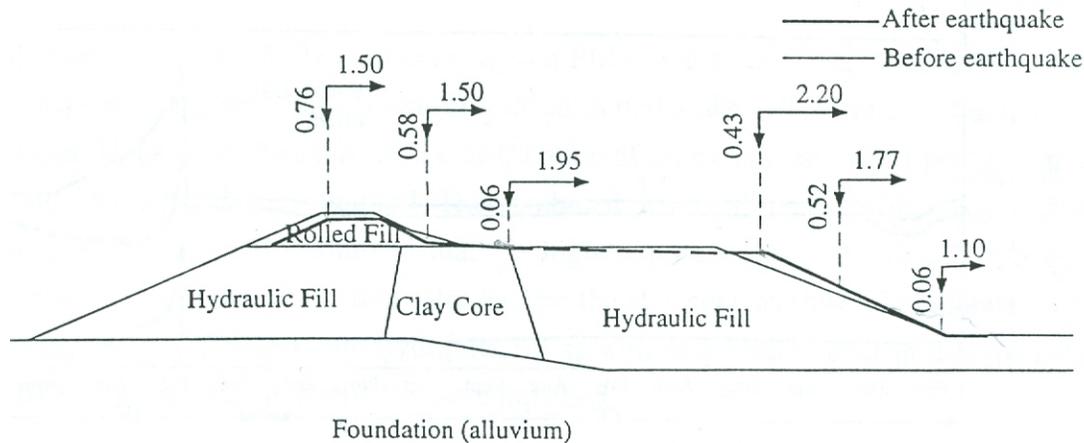
Surveys taken after the earthquake revealed that the entire upper portion of the dam had moved downstream around 2 m and the crest had moved downward around three-quarters of a meter. Based on the sketch in Figure 5, only the upper rolled-fill portion moved on the upstream side. Of significance is the movement along the surface of the berm. Here, the movements were predominantly in the lateral direction with hardly any settlement.

Figure 6 Movements associated with the earthquake

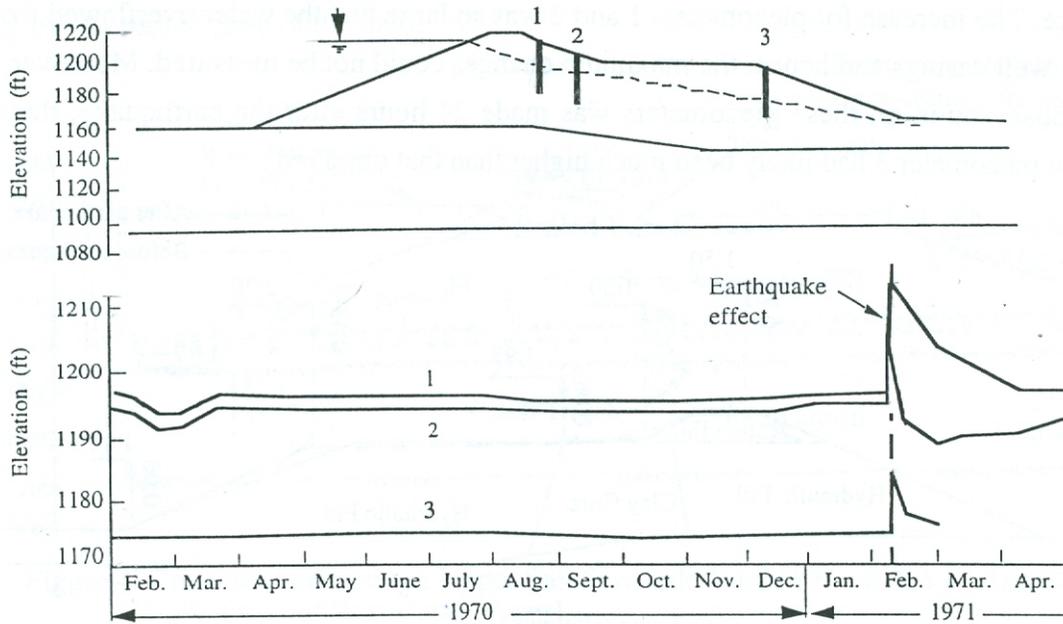
There were three piezometers in the dam, as shown in Figure 7. As indicated by the piezometric records, there was a sudden and dramatic increase in pore-pressures. Even 24 hours after the earthquake, water was still running out of the top of Piezometers 1 and 2. This is of significance, since these piezometers are in the core area of the dam, especially Piezometer 2. The peak in Piezometer 3 was likely higher than what was measured, due to some dissipation within the 24 hours between the event and the readings. These piezometers provide definitive evidence that substantial excess pore-pressures resulted from the shaking.

Figure 7 Piezometers and pore-pressure responses due to the shaking

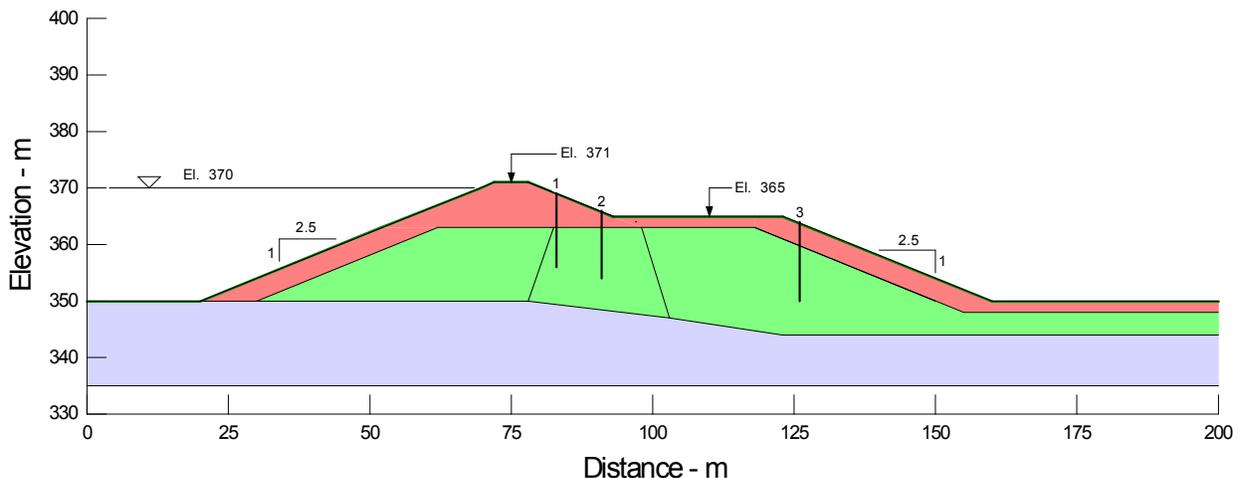
For the analysis here, the Upper Dam cross-section was idealized, as shown in Figure 8.

Figure 8 Numerical analysis model of the Upper San Fernando Dam

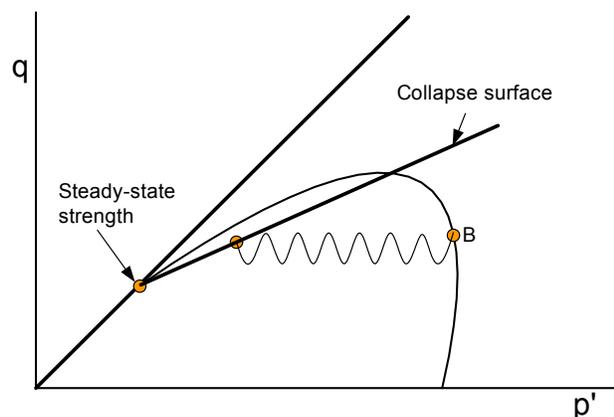
Chapter 1 in the QUAKE/W Engineering Book presents a section on the Behavior of Fine Sand. This Section introduces the concept of a Collapse Surface. Figure 9 is one of the diagrams presented in Chapter 1. Fundamentally, any stress point such as Point B could experience the development of excess pore pressures during an earthquake, until the mean effective stress p' reaches the collapse surface. Once on the collapse surface, the strength may fall down to the steady-state strength. On the other hand, the initial stress Point B in Figure 10 may experience the development of excess pore-pressures, but the strength will not suddenly fall, since the initial deviatoric stress q is below the steady-state strength. This is discussed in more detail in the QUAKE/W Engineering Book.

Figure 9 Stress path of contractive loose sand

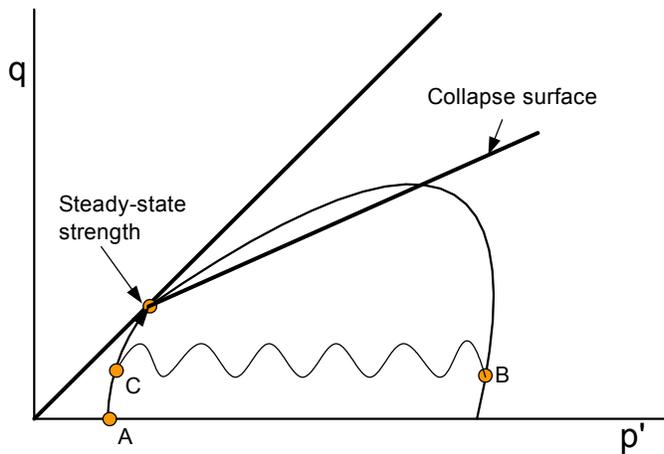
Figure 10 Stress path of dense dilative sand

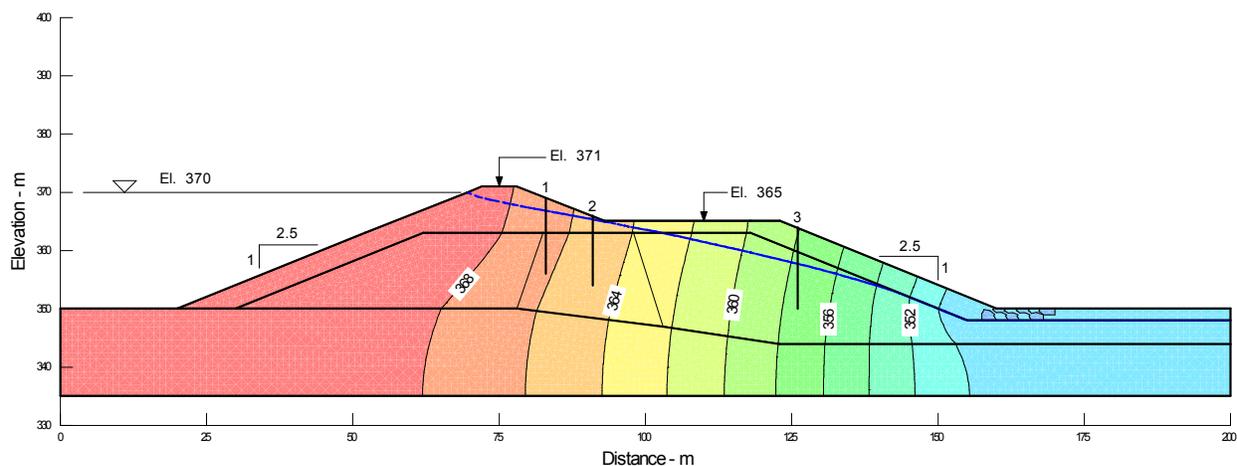
Figure 11 shows the resulting piezometric line (watertable) and total head contours (equipotential lines). Note that the piezometric line comes very close to the ground surface at the toe of the upper rolled section.

Figure 11 Long term steady-state seepage and pore-pressure conditions

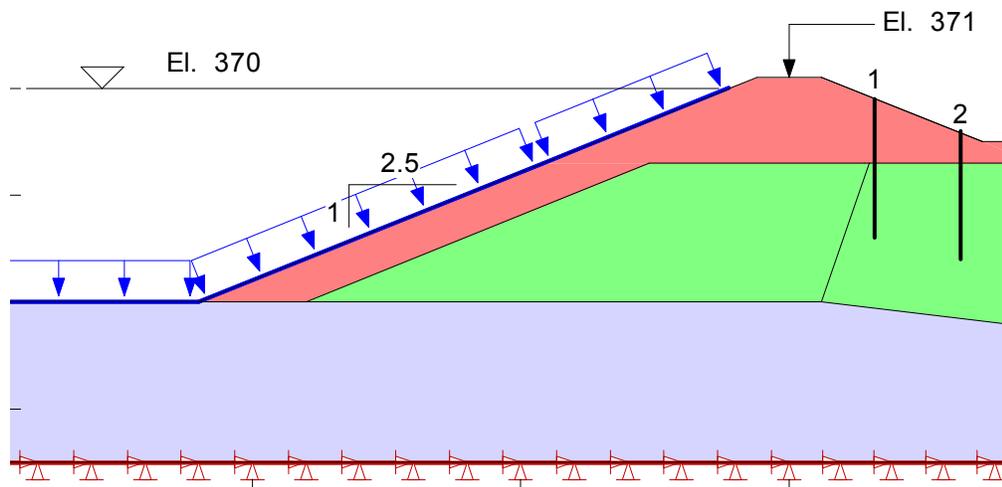
It is important to include the weight of the reservoir water in the static stress analysis. This is done by applying a fluid pressure boundary on the region edges in contact with the reservoir. This is illustrated in Figure 12. The resulting vertical effective stresses, for example, are as shown in Figure 13.

Figure 12 The reservoir water weight boundary condition

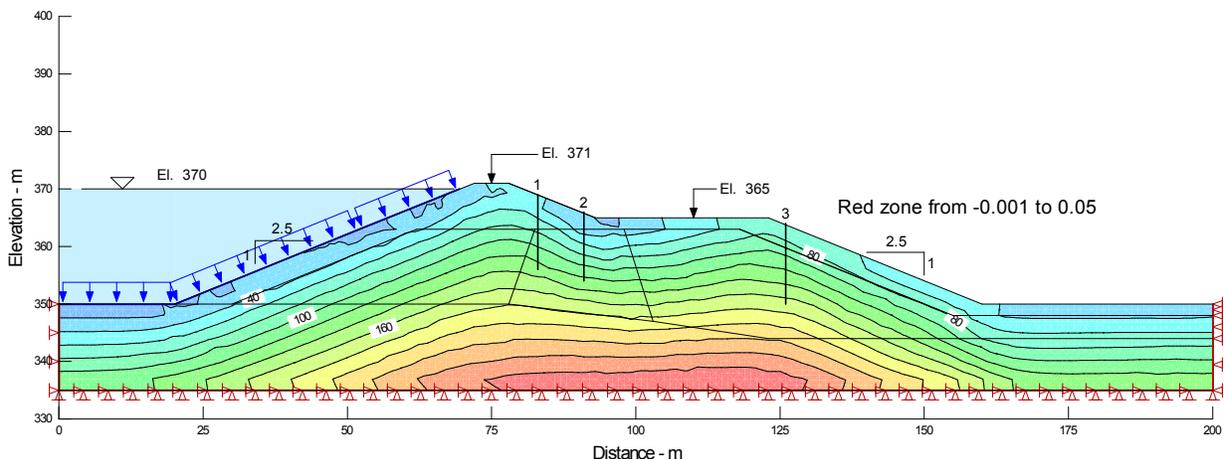
Figure 13 Initial static vertical effective stresses

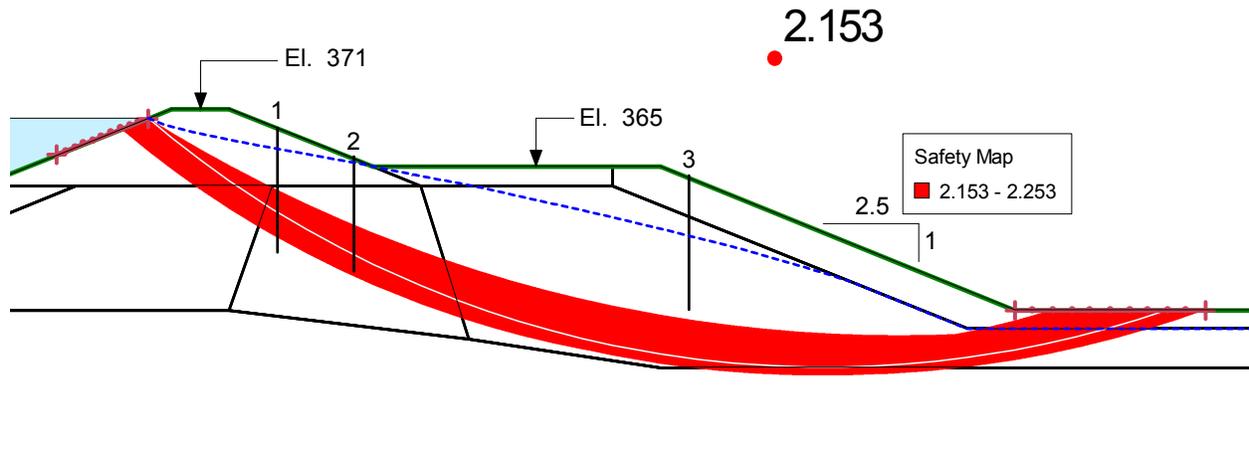
As a reference point, it is useful to know the factor of safety under static conditions before the slide occurred. Based on the SEEP/W pore-pressures and QUAKE/W static stresses, the factor of safety is well above 2.0, as illustrated in Figure 14. This is consistent with the findings by Seed et al., who concluded that the margin of safety against instability under the static conditions was fairly high.

Figure 14 Overall margin of safety before the earthquake

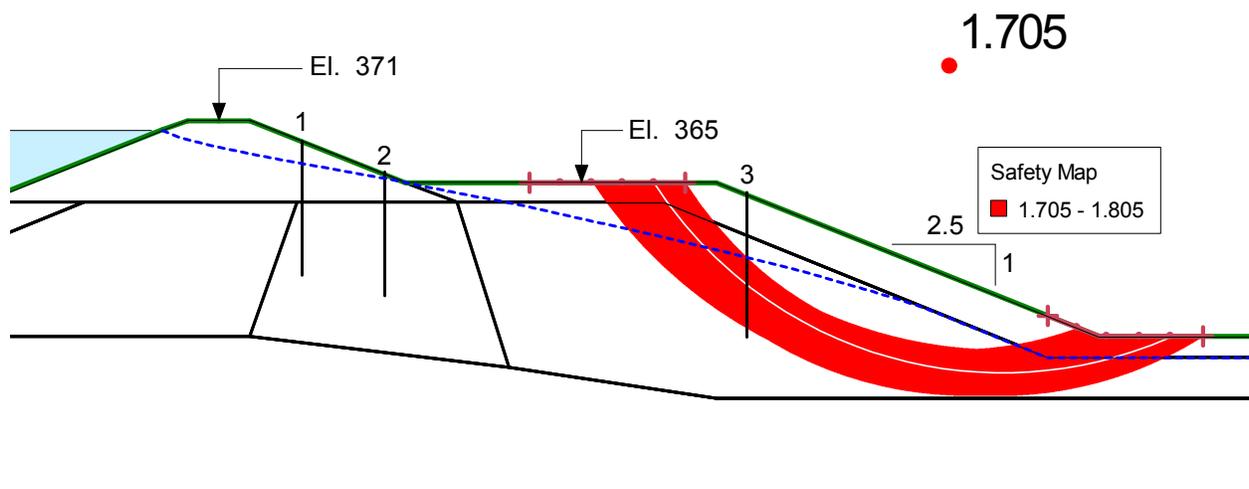
The safety factor of the downstream slope of the hydraulic fill section is shown in Figure 15. As with the overall factor of safety, the factor of safety for this potential mode of failure is also fairly high. The factor of safety in the red band is between 1.70 and 1.80.

Figure 15 Downstream slope margin of safety before the earthquake

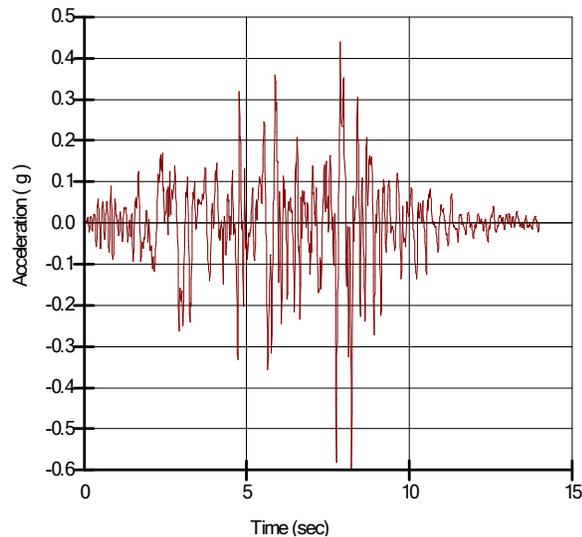
Time history records of the San Fernando earthquake are available from various seismic stations. Most of the past studies have been based on a recording station located on the abutment of the nearby Pacoima Dam, located about 5 km east of San Fernando. The base rock peak acceleration at the San Fernando site has been estimated to be about 0.6 g, and the record is scaled to a maximum 0.6 g to match this value. The time history record used in the analysis here is given in Figure 16. Small vibrations at the start and end of the publicly available record have been removed, limiting the total duration to 14 seconds, which includes all the significant peaks. The data points are presented at a constant 0.01 sec interval.

Figure 16 Earthquake record based the station at the Pacoima Dam abutment

Figure 20 shows the response at the crest of the Dam. There is not much difference between this record and the input record in Figure 16. There are a couple of spikes greater than 1g, but outside these spikes the response is more or less a reflection of the earthquake record. In other words, there is no significant amplification or unrealistic damping. This is consistent with the conclusions reached by Seed et al.

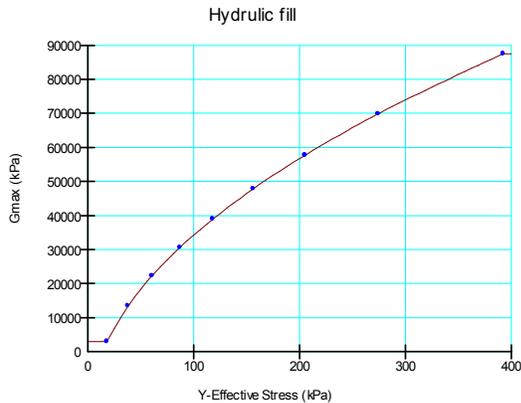
The small strain shear moduli G_{max} are specified as functions. Figure 17 shows the function adopted for the hydraulic fill. The minimum value is 3000 kPa. Functions for the shell material and the alluvium have a similar shape, but with a higher minimum value.

Figure 17 The G_{max} function for the hydraulic fill

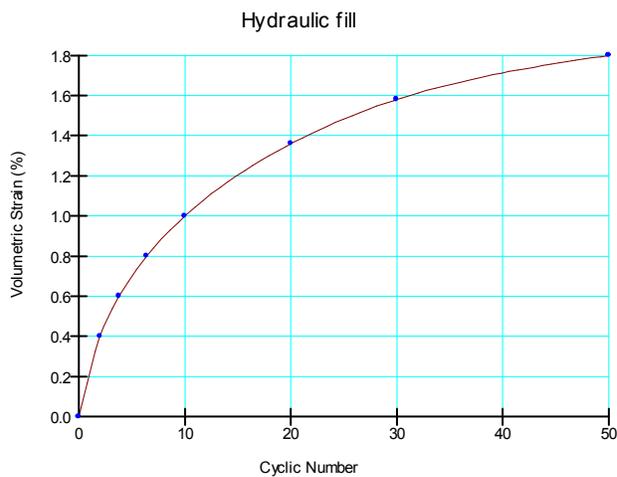
The Nonlinear Analysis method in QUAKE/W is associated with the MFS (Martin Finn Seed) pore-pressure model. With this model, it is necessary to specify a function such as shown in Figure 18, which defines the volumetric strain that will occur under a given number of cycles for a given shear-strain amplitude. For this analysis, it is specified that the curve in Figure 18 was obtained at shear-strain amplitude of 0.5 percent.

Figure 18 MFS volumetric strain function

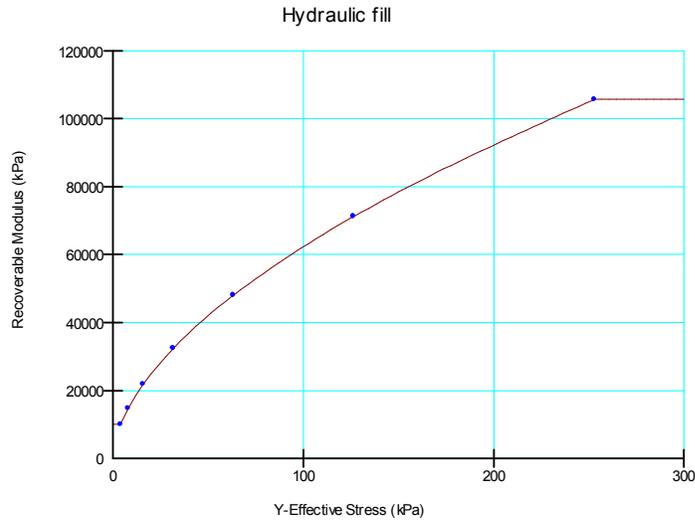
The second piece of data required for the MFS pore-pressure model is the Recoverable Modulus function. This is basically the slope of an unloading curve from a one-dimensional odometer test. The curve used in the analysis here is shown in Figure 19.

Figure 19 Recoverable modulus function

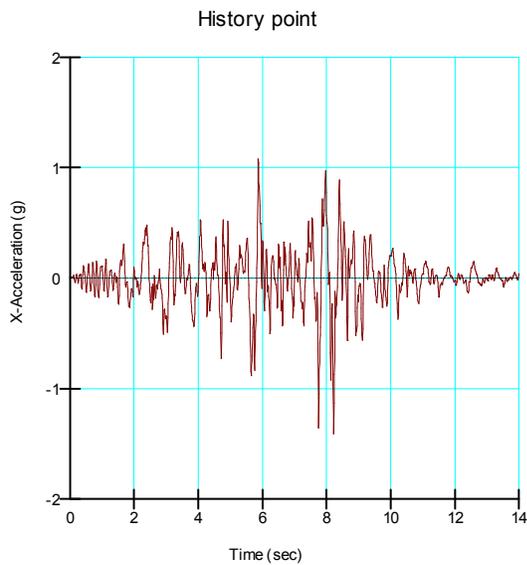
Figure 20 Acceleration versus time at the Dam crest

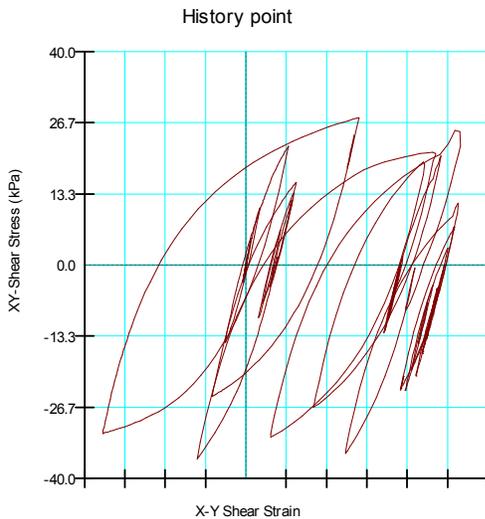
History Points are also useful for examining the stress-strain response at selected location. A History Point was placed at the base of Piezometer 2. The computed shear stress-shear strain path at this location during the shaking is presented in Figure 21.

Figure 21 Typical stress-strain path during the shaking

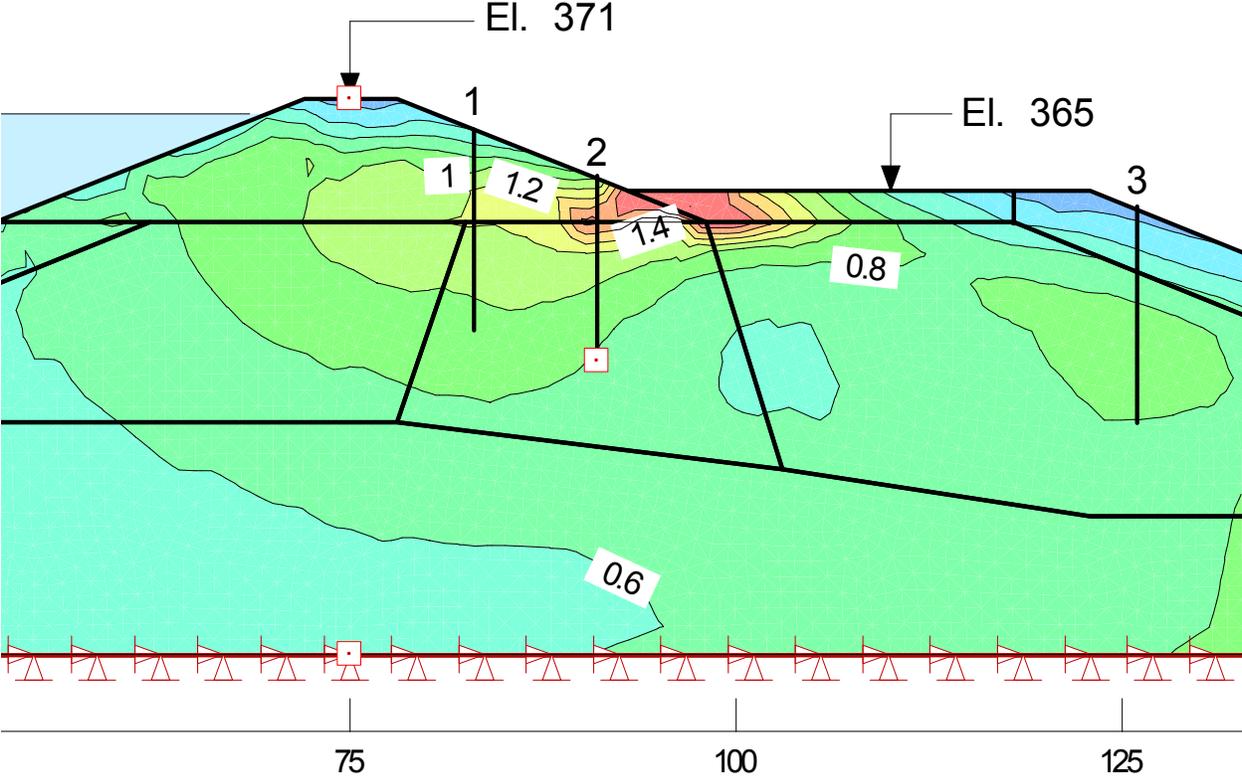
Figure 22 shows contours of q/p' stress ratios under the initial static stresses. A point of significance is the high q/p' ratios in the hydraulic fill underneath the dam crest. This means that there is a zone where the initial q/p' points are near the collapse surface, as discussed earlier in Section 7. The soil strength in this zone could easily fall down to the steady-state strength with a small amount of shaking. There is no yellow shaded area in Figure 23, which indicates that there is zone of initial stress states that are near but still below the collapse surface.

Figure 22 q/p' stress ratios under initial static stresses

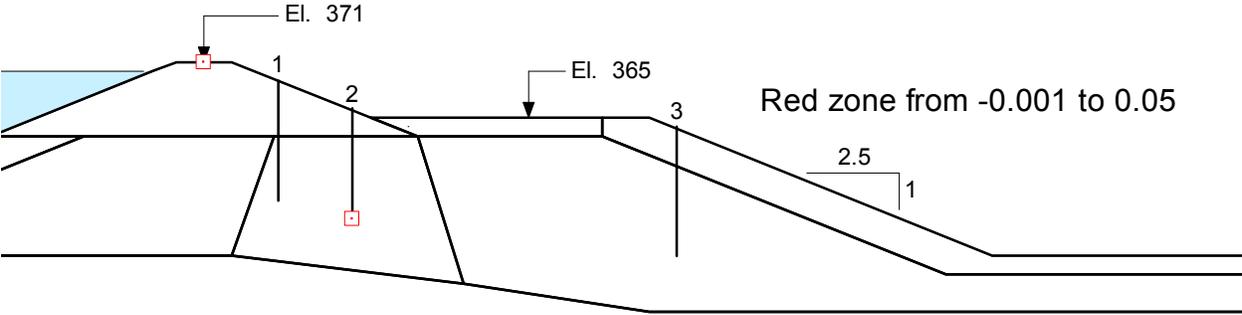
Figure 23 Zone of liquefaction based on initial q/p' stress ratios relative to collapse surface

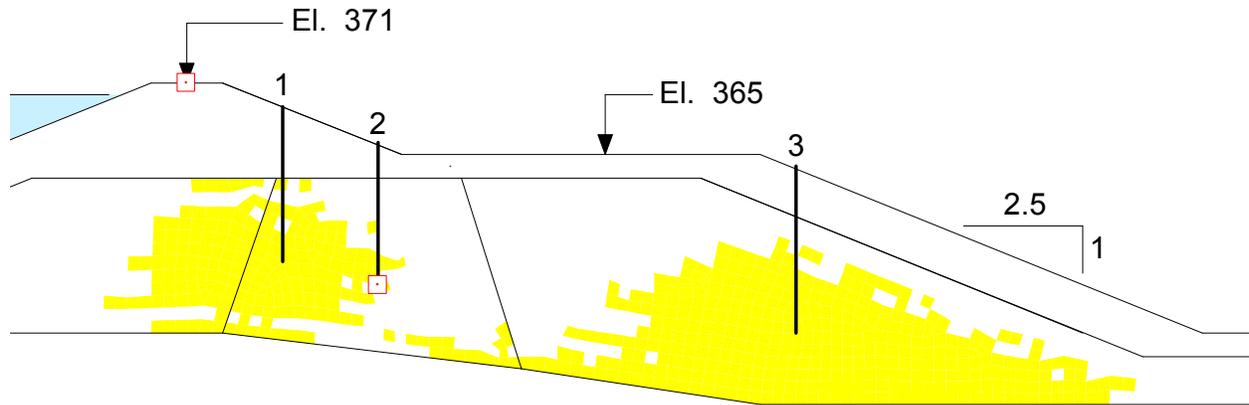
During the shaking, excess pore-pressures will develop, causing other elements to reach the collapse surface as discussed earlier; in other words, to liquefy. Figure 24 shows the liquefied zone at the end of the shaking.

Figure 24 Liquefied zone at the end of shaking.

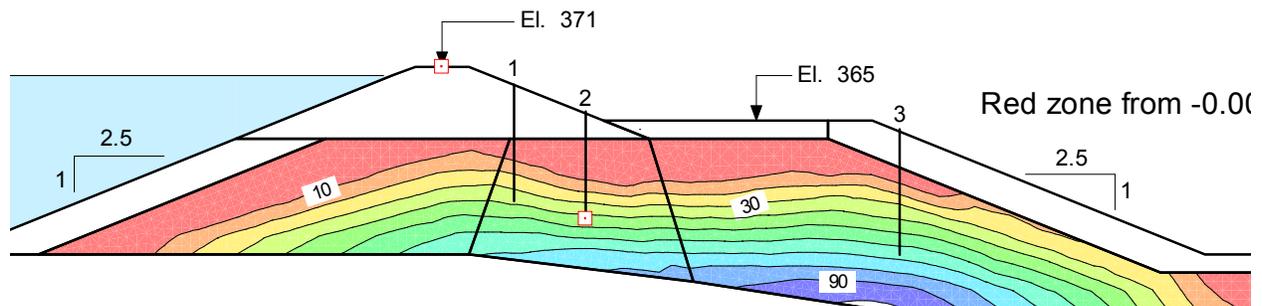
Figure 25 shows contours of the excess pore-pressure at the end of the shaking. The highest excess pore-pressures (90 kPa) are at the bottom of the hydraulic fill below the downstream berm crest.

Figure 25 Contours of excess pore-pressure at the end of shaking

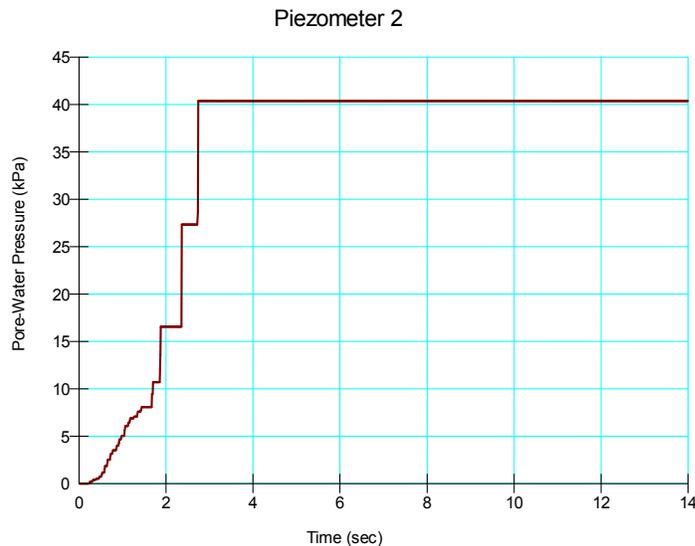
Figure 26 shows the build-up of excess pore-pressures at the bottom tip of Piezometer 2. The maximum excess pore-pressure is 43.5 kPa. This is a pressure head of 4.4 m (about 14.5 feet).

Figure 26 Excess pore-pressure at Piezometer 2

The View Results Information command can be used to get the final total H at the base tip of Piezometer 2. The computed H is 369 m. The ground surface at Piezometer 2 is 366 m. The total head H being greater than the ground surface elevation means water would be flowing from the piezometer casing, which is in keeping with observations.

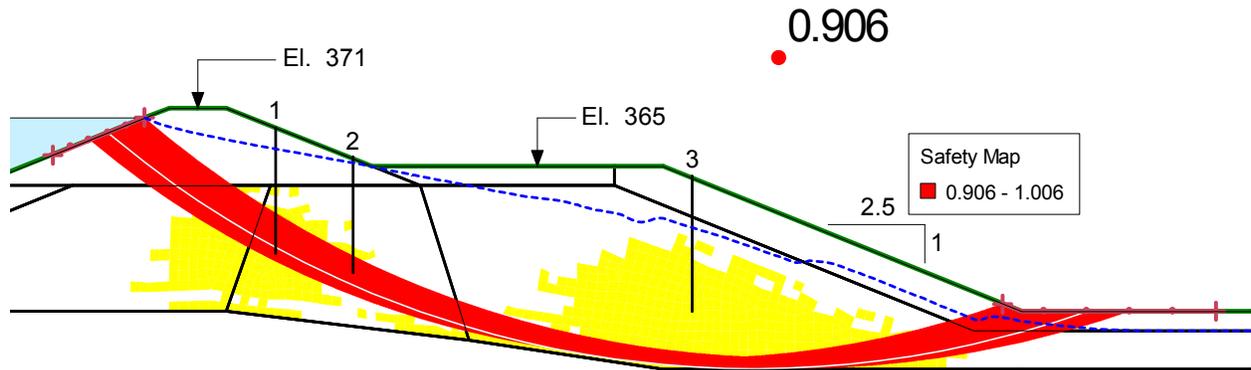
The safety factor for the overall stability case is 0.923 the steady-state strength is used in the liquefied zones of the dam (Figure 27) as compared to 1.11 using the collapse surface properties ($\phi' = 20$; $C_{ss} = 35$

Figure 27 Post-earthquake overall stability

It is of significant interest that the overall critical slip surface in Figure 27 on the upstream face is exactly in the area where large longitudinal cracks had formed under the reservoir water surface. These cracks only became visible after the reservoir was drawn down, some 12 days after the earthquake.

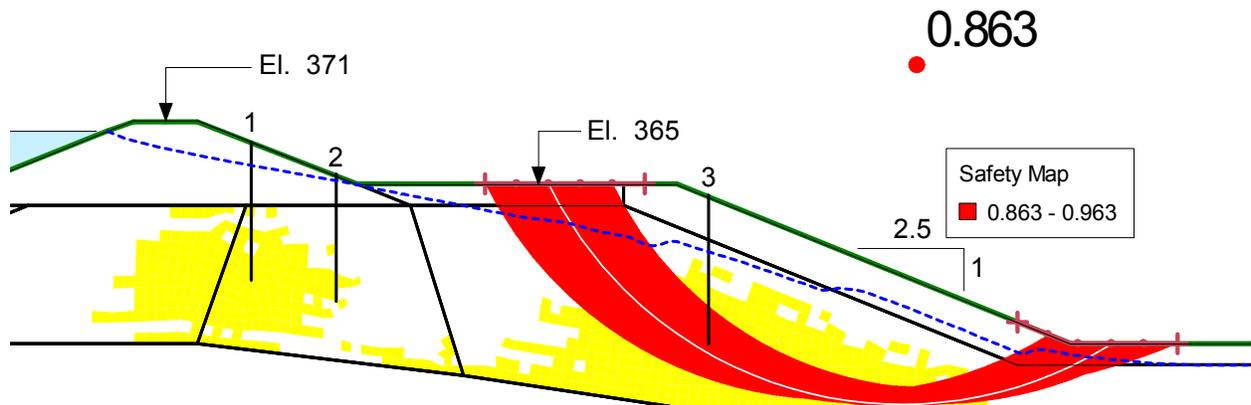
kPa) and 1.28 using effective stress strength properties ($\phi' = 34$). In the downstream local case, the safety factor is 0.885 if the steady-state strength is used in the liquefied zones of the dam (Figure 28) as compared to 0.978 using the collapse surface properties ($\phi' = 20$; $C_{ss} = 35$ kPa) and 1.054 using effective stress strength properties ($\phi' = 34$). Consequently, it could be argued that in the local downstream case, the C_{ss} strength is not required to explain the observed behavior, but it is certainly required to explain the overall behavior.

Figure 28 Post-earthquake stability of the downstream slope at the end of the earthquake

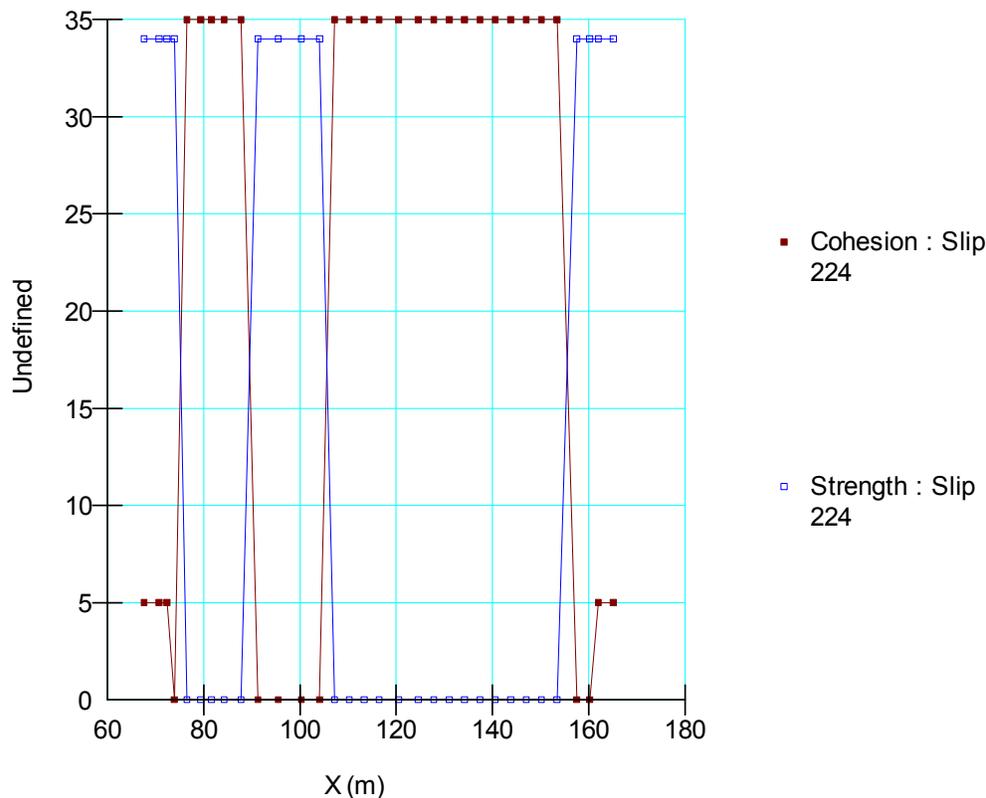
Figure 29 shows the cohesive strength along the overall critical slip surface. Note how along much of the slip surface, the cohesion is at 35 kPa, which is the specified C_{ss} . Where C_{ss} is 35, ϕ' is zero and therefore the frictional component of the strength is zero.

Figure 29 Strength along the overall critical slip surface

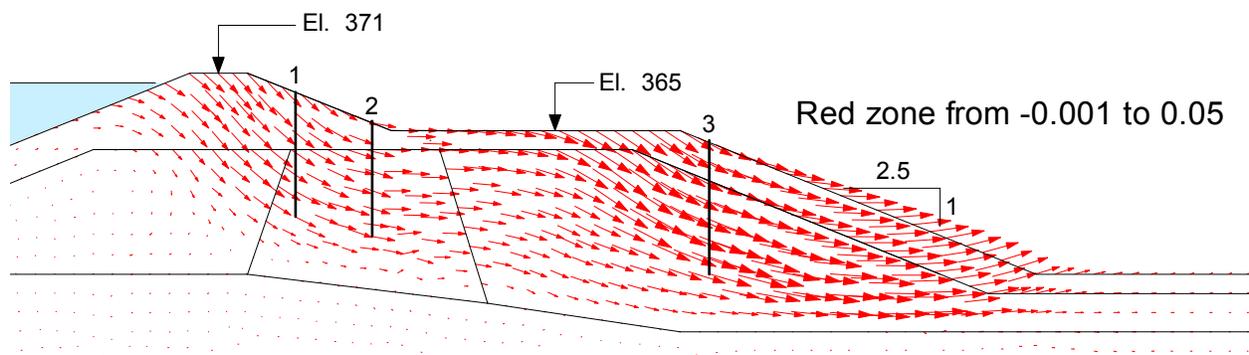
Figure 30 shows the displacement vectors from the post-earthquake SIGMA/W stress re-distribution. The movement patterns seem to be a reasonable approximation of what actually happened. The vectors in the upper rolled fill section are down and to the right, and the movement vectors start on the upstream

face in the area where the longitudinal cracks developed. To the right of the upper rolled-fill section, the movement is predominately horizontal, which is also consistent with the observations discussed earlier in Section 5.

Figure 30 Post-earthquake movement directions

Generally, the computed movement patterns are entirely consistent with the field observations, and the conclusions arrived at by Seed et al. They concluded that, the *zone of movements within the dam extended vertically over a large portion of the embankment and was not limited to well-defined slip surface at depth*. The computed movement patterns in Figure 30 certainly confirm this.

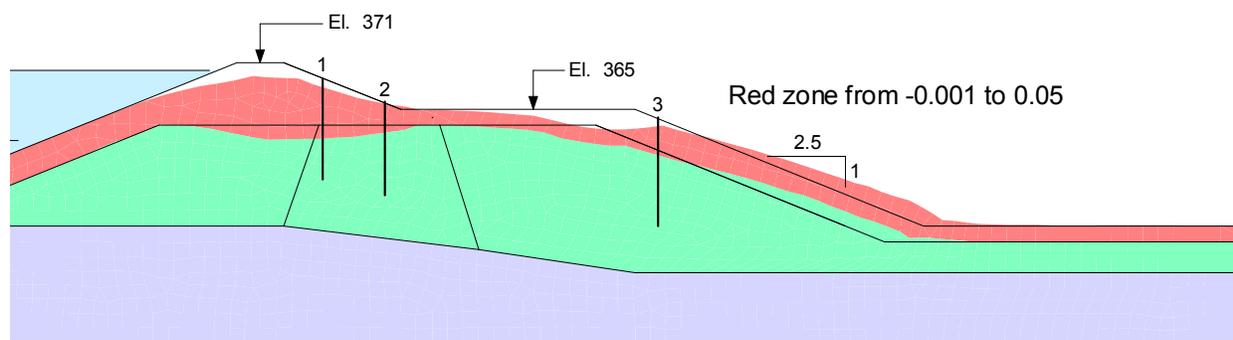
Another way to view the movements is as a deformed section, as in Figure 31. The view gives an appreciation of the down and right movement of the upper rolled fill section and compression bulging in the downstream toe area.

Figure 31 A deformed section at a 10X exaggeration
